# Galling Prevention and Run-In Torque Reduction

An aircraft structures manufacturing company was encountering galling when installing titanium bolts (type NAS1581) to threaded stainless steel nut-plates (type MS21060L6). The fastener system is used to attach a large exterior communications structure to the airframe.

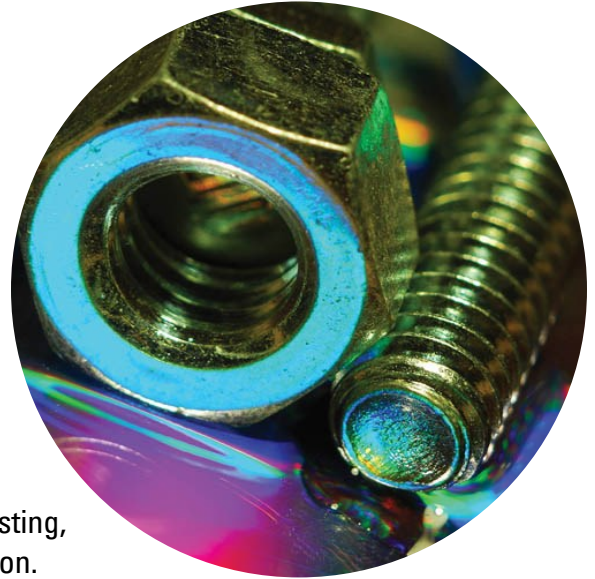
As shown, the run-in torque was low and decreased with every installation/removal cycle. No evidence of galling was noted and the coating was found to be in good condition throughout the test.

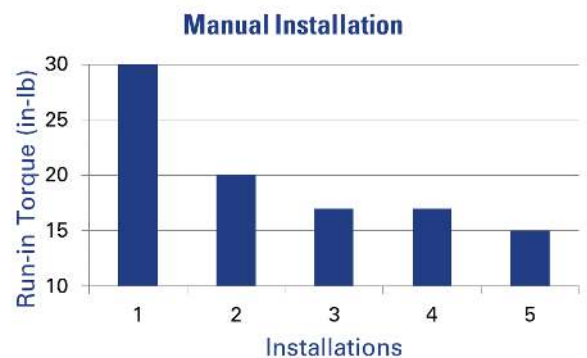
### Manual Installation:

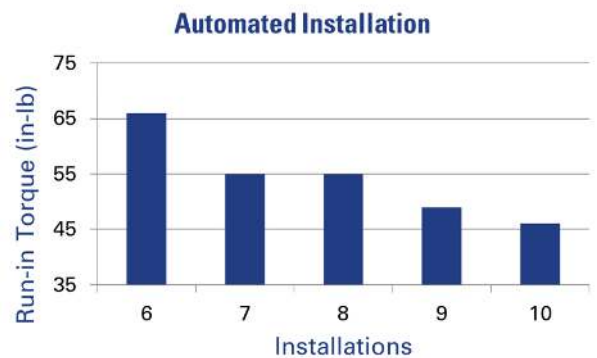
### Automated Installation:

The run-in torque measured after the 5th cycle was 32 in-pounds and no evidence of galling or coating loss was noted. The data from the subsequent five cycles (#s 6-10) is shown. Interestingly, the 6th cycle run-in torque was higher but then consistently decreased with each cycle. No evidence of galling was noted throughout; minimal coating degradation was observed.
