DICRONITE®

GEARBOX TEMPERATURE REDUCTION

Dicronite® helped reduce operating temperatures to minimize component wear and maintenance need

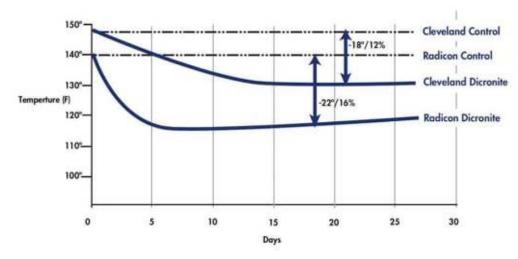
Operating temperatures were reduced by 16% (22°F) in the Radicon gearbox and 12% (18°F) in the Cleveland gearbox, exceeding the engineering requirement.

Comparison testing of two gearboxes (Radicon and Cleveland) with and without Dicronite® was conducted. Test conditions were:

- Speed: 479 FPM (600 FPM max)
- Timeframe: 27 days continuous running
