# DICRONITE®

## Plastic Molding Heat Seal Pins

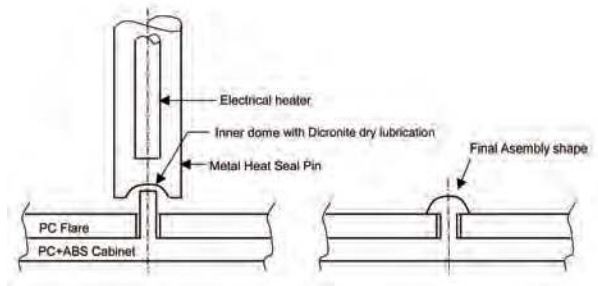
**Dicronite dry lubrication** is being applied to the cavity and sliding surfaces of the pins. As a result:
