# DICRONITE®

## Anti-Galling/ Run-In Torque Reduction

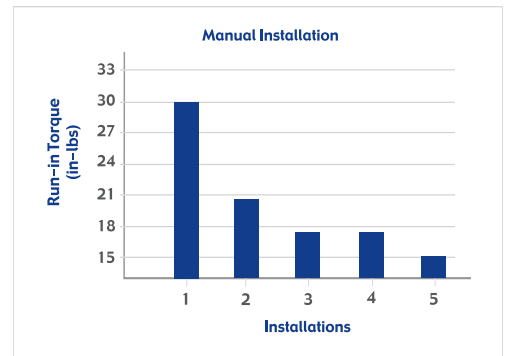
- A set of Dicronite dry lubricated bolts and nutplates were prepared for testing.
- Manual Installation: As shown in Figure 1, the run-in torque was low and decreased with every installation/removal cycle. No evidence of galling was noted and the coating was found to be in good condition throughout the test.
